Upper Mill Meadow Restoration Area

T. 7 S., R. 7 W., Sec. 9

Meadow Site Description – Mary's Peak Resource Area, Salem District BLM

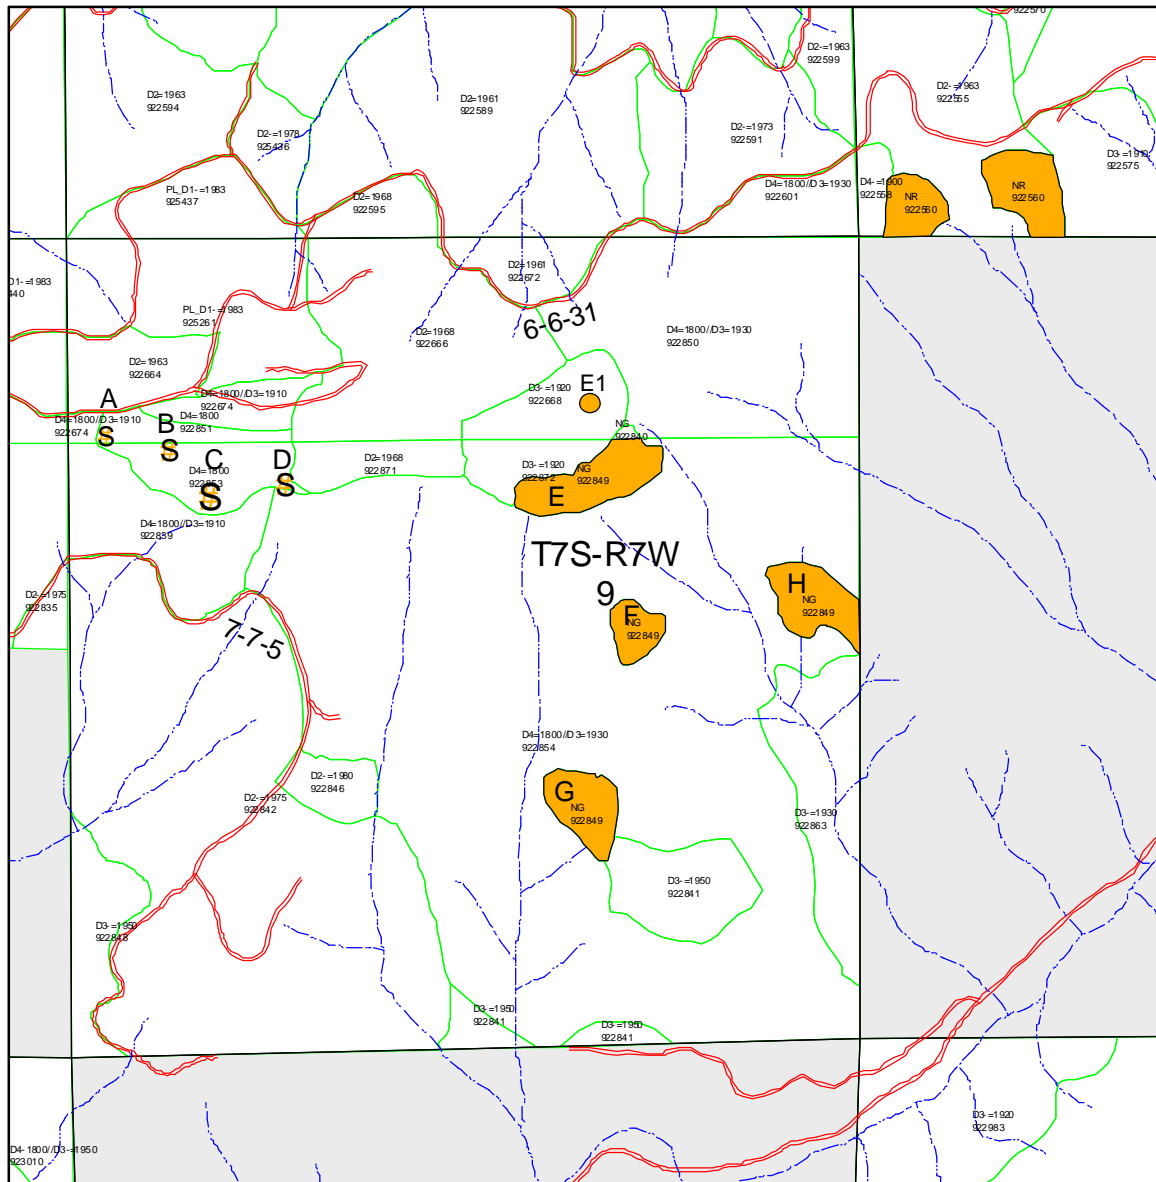
Dry Meadow/cliffs/rock gardens
LUA: AMR
Elev: 1600-2400'
Conifer encroachment
Native species restoration
Minor oak release
